**FINAL  
AFTER ACTION REPORT  
TIME CRITICAL REMOVAL ACTION**

**TRICKLING FILTER  
OLD WASTEWATER TREATMENT PLANT  
WALLOPS FLIGHT FACILITY, VIRGINIA**

**WESTON SOLUTIONS, INC.  
Raleigh, North Carolina**

**NOVEMBER 2006**

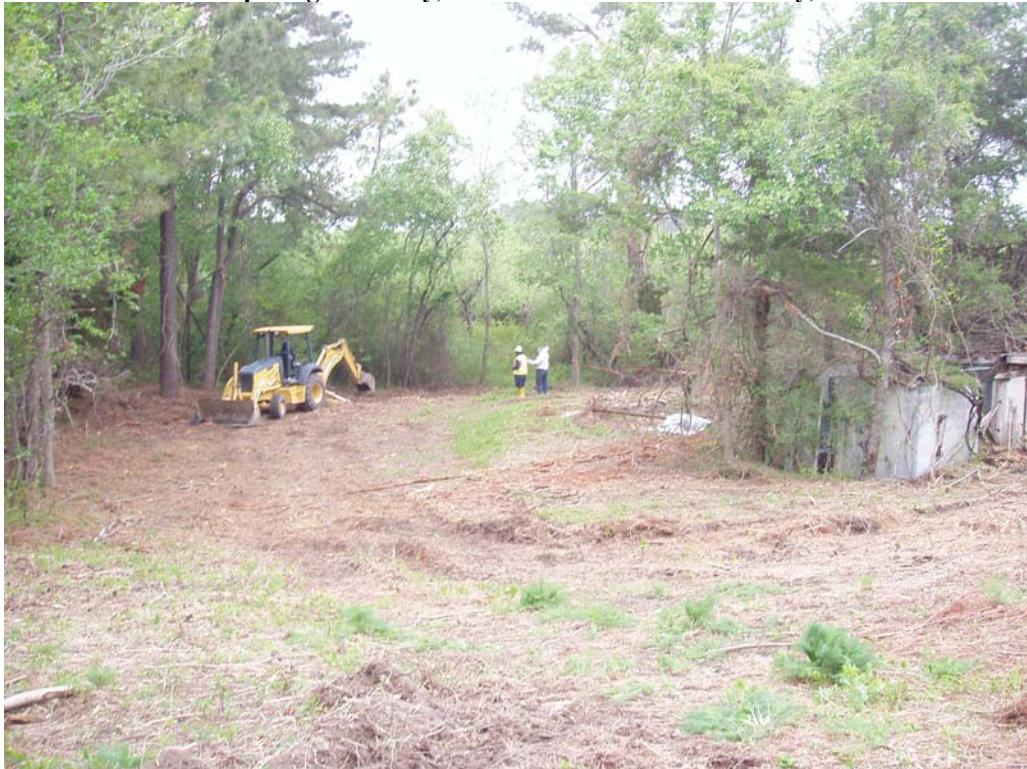
**PHOTO NUMBER:** WFF1-TCRA-050806-01      **DATE:** May 8, 2006      **PHOTOGRAPHY BY:** Ed Mackey

**SCENE:** Construction of temporary access road. Pump house (cinder block building) and rotating arms of the trickling filter located on the right (east) side of photograph. Photograph taken facing northeast.

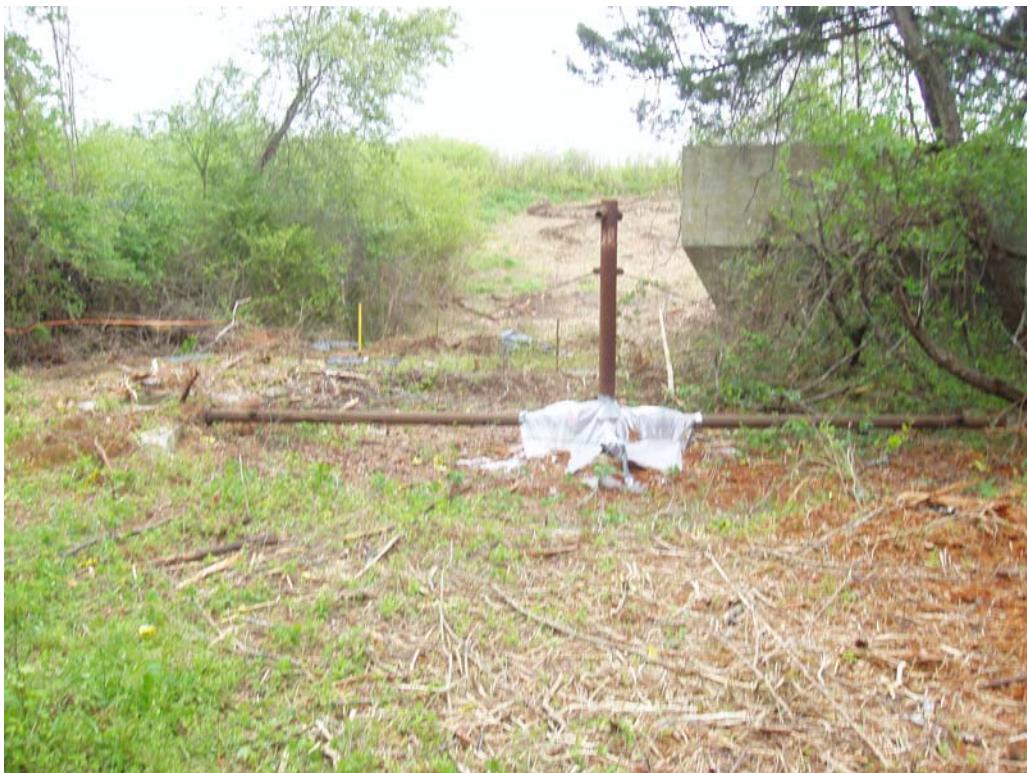
**PHOTO NUMBER:** WFF1-TCRA-050806-02      **DATE:** May 8, 2006      **PHOTOGRAPHY BY:** Ed Mackey

**SCENE:** Upper steel pedestal and rotating arms of the trickling filter; the mercury seal portion of the rotary distributor is covered/wrapped in poly sheeting. Portion of concrete settling tank located in background. Photograph taken facing east.

On May 9, 2006, the upper steel pedestal and two rotary distribution arms were removed and inspected to determine if elemental mercury remained in the seal. Sediment/soil in the distribution arms and pedestal equipment was removed and scanned for the presence of mercury using a portable mercury vapor analyzer. Readings were not recorded above background levels. On May 17, 2006, the mercury seal portion of the rotary distributor at the center pier was removed and placed in a U.S. Department of Transportation (USDOT)-approved 85-gallon drum for shipment off site as hazardous waste.

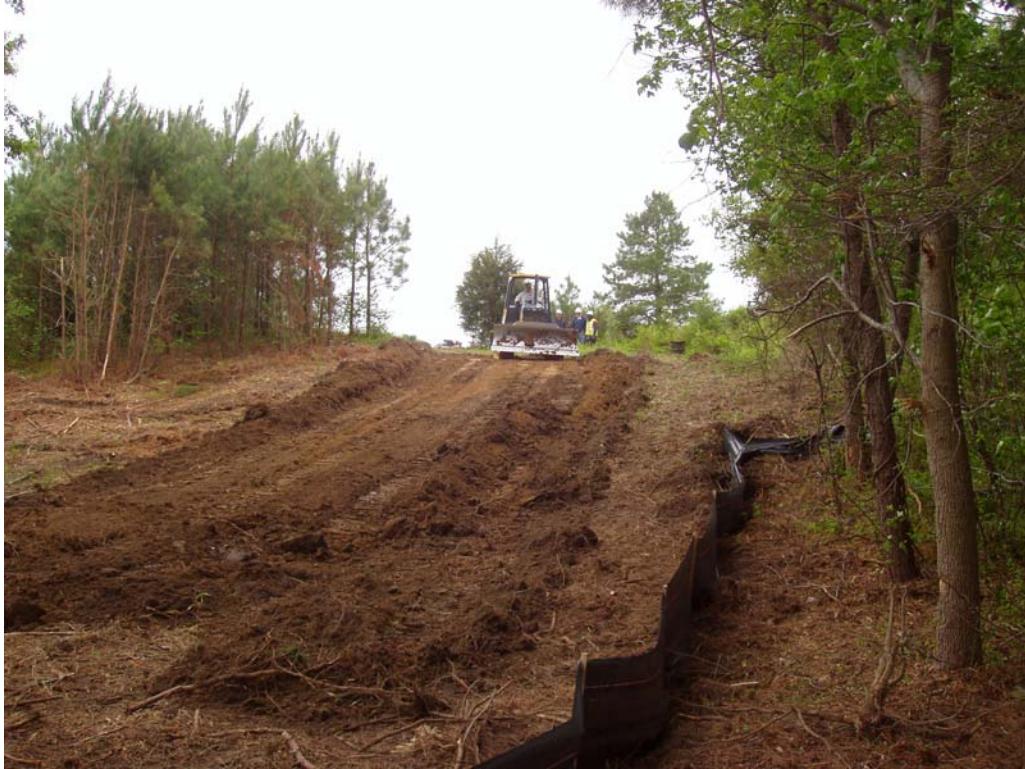
**SCENE:** Cutting/re-grading hillside as part of construction of temporary access road. Photograph taken facing south.  
**PHOTO NUMBER:** WFF1-TCRA-050806-04      **DATE:** May 8, 2006      **PHOTOGRAPHY BY:** Ed Mackey

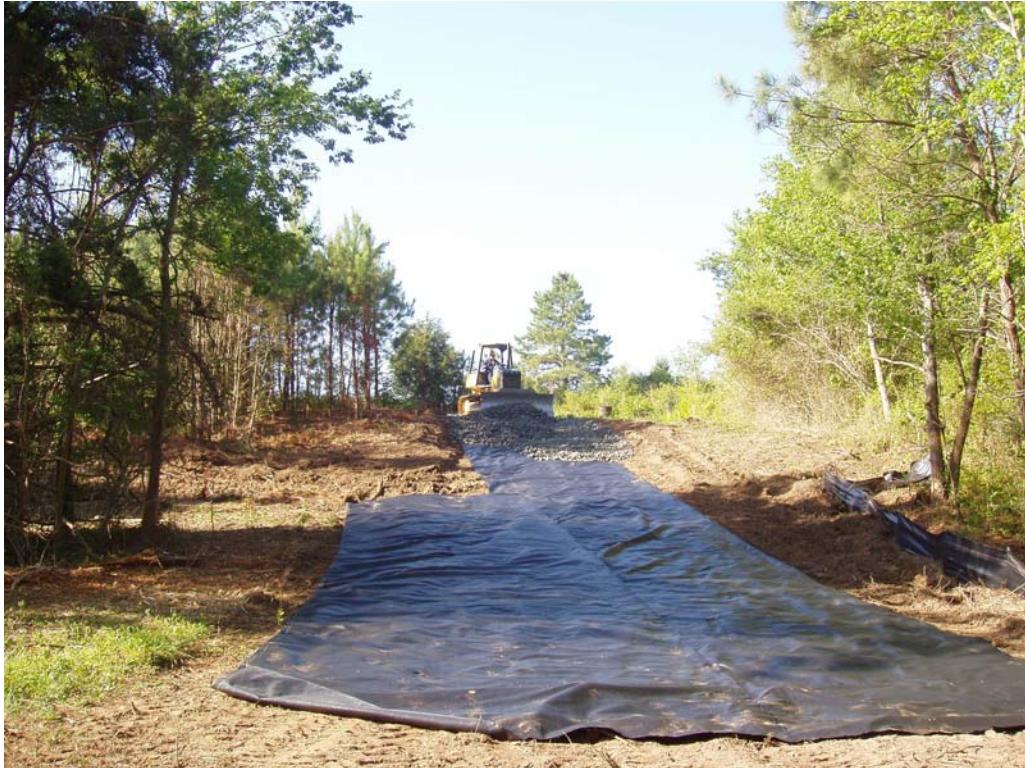
**SCENE:** Spreading gravel and laying geotextile fabric as part of construction of temporary access road. Photograph taken facing south.  
**PHOTO NUMBER:** WFF1-TCRA-050906-02      **DATE:** May 9, 2006      **PHOTOGRAPHY BY:** Ed Mackey

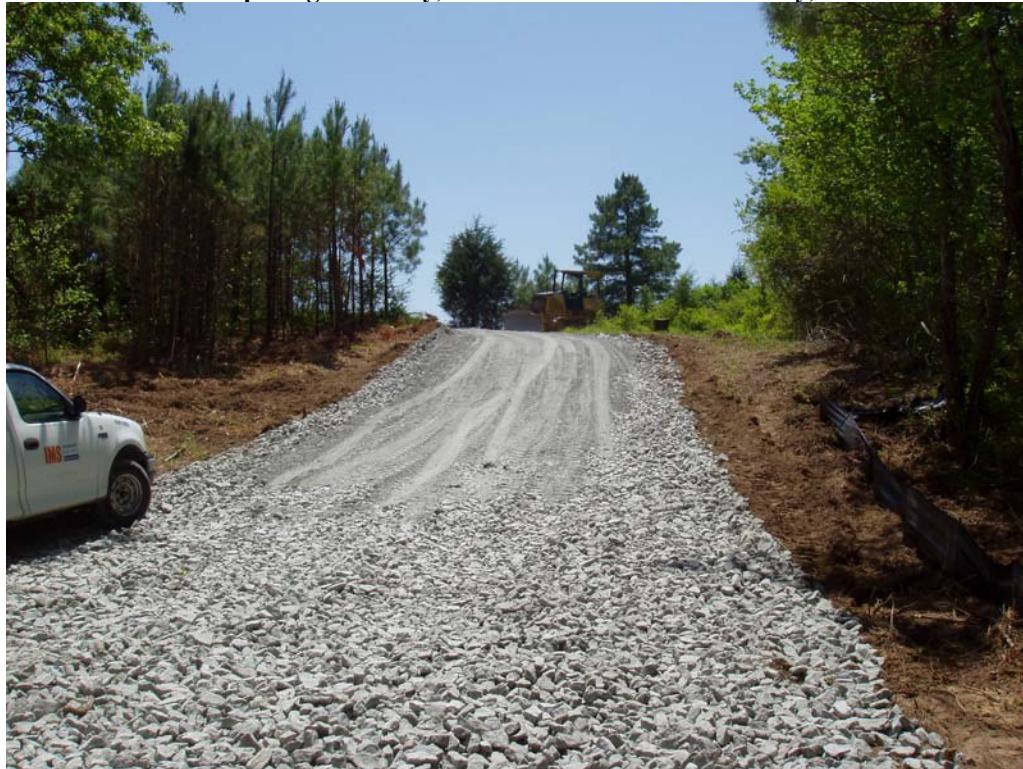
**PHOTO NUMBER:** WFF1-TCRA-050906-03      **DATE:** May 9, 2006      **PHOTOGRAPHY BY:** Ed Mackey

**SCENE:** Completed gravel/crush n' run temporary access road. Photograph taken facing south.

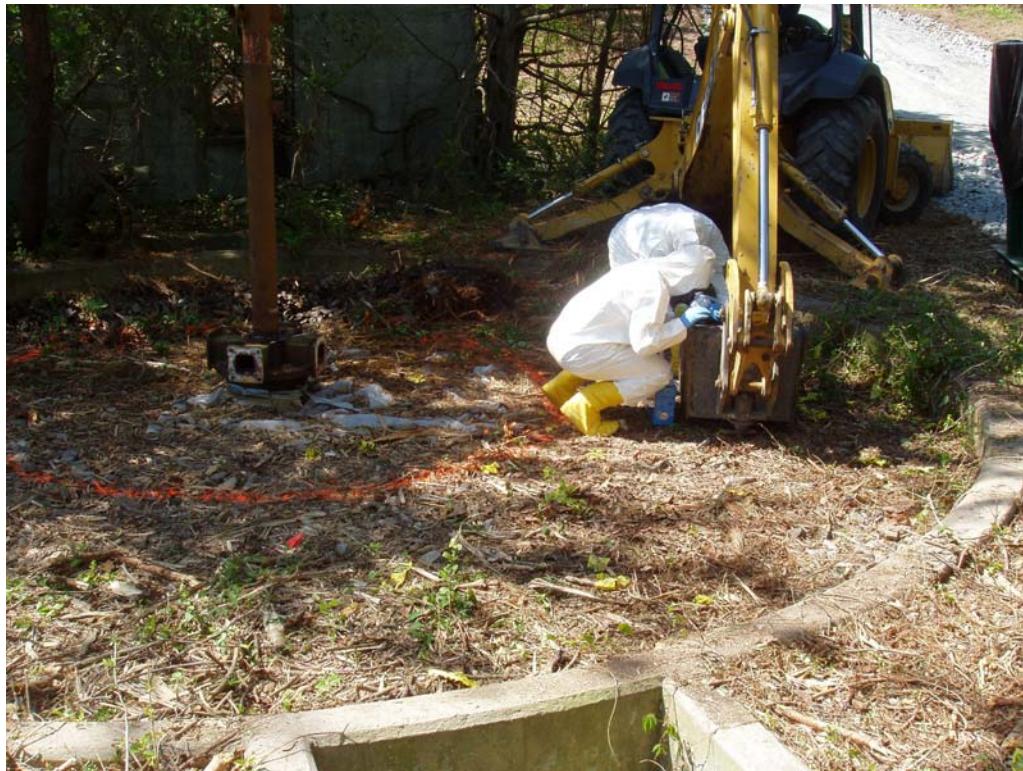
**PHOTO NUMBER:** WFF1-TCRA-051006-02      **DATE:** May 10, 2006      **PHOTOGRAPHY BY:** Ed Mackey

**SCENE:** Inspecting and screening bucket of trickling filter stone media from Zone 2 with portable mercury vapor analyzer. Zone 1 and Zone 2 delineated by orange paint line. Portion of northern wet well in foreground, and pump house building in background. Photograph taken facing south-southwest.

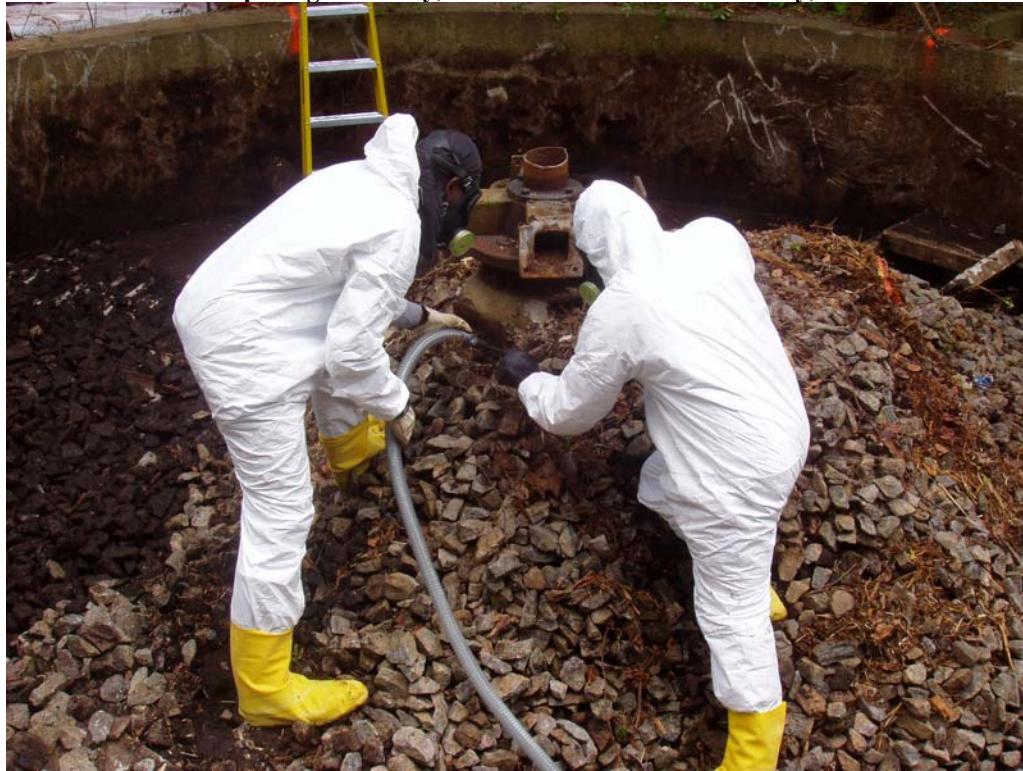
**PHOTO NUMBER:** WFF1-TCRA-051206-02      **DATE:** May 12, 2006      **PHOTOGRAPHY BY:** Ed Mackey

**SCENE:** Vacuuming liquid mercury from around the center pedestal and the mercury seal portion of the rotary distributor in the trickling filter tank. Photograph taken facing southeast.

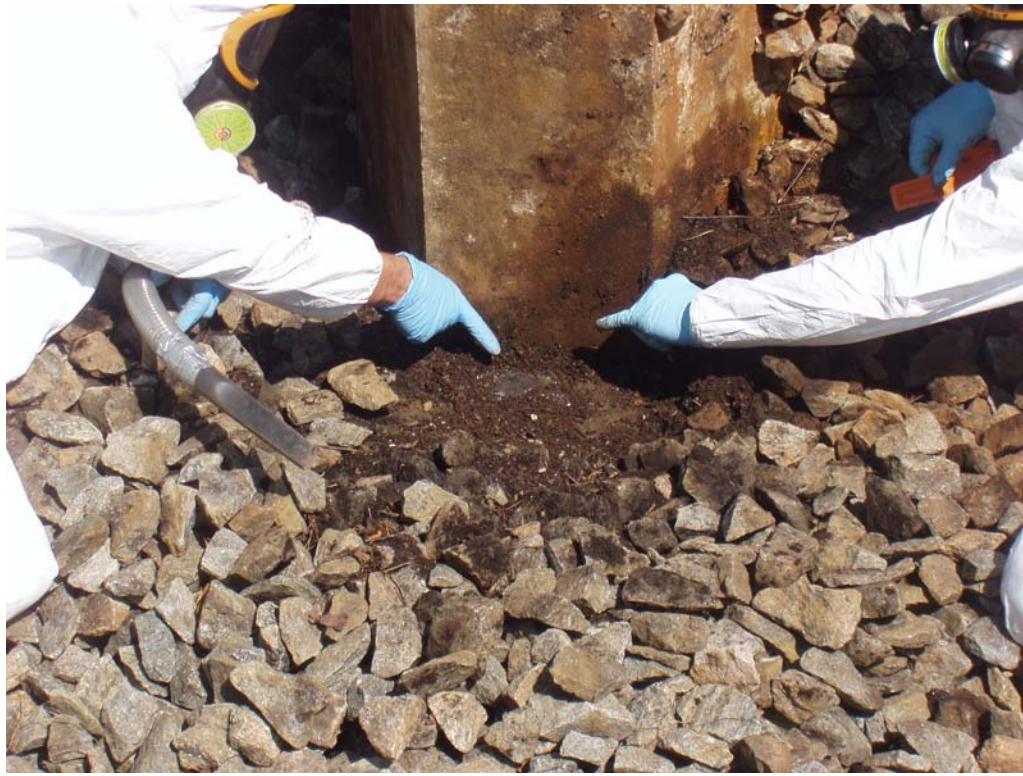
**PHOTO NUMBER:** WFF1-TCRA-051506-02      **DATE:** May 15, 2006      **PHOTOGRAPHY BY:** Greg Ford

**SCENE:** Vacuuming pool of liquid mercury at the base of the center pedestal in the trickling filter tank. Photograph taken facing east.

On May 16, 2006, following removal of the trickling filter stone media, the underdrain system was removed. During this process, elemental mercury was vacuumed and removed. The underdrain system was removed to expose the concrete bottom of the filter tank. Clay tile, piping, steel, sludge, and sediment removed from the underdrain system was screened for mercury and containerized in USDOT-approved 55-gallon drums for off-site disposal/recycling as hazardous waste. Concrete grates covering the trench were cleaned by scrubbing MercSorb®, followed by placement in roll-off container No. 8.

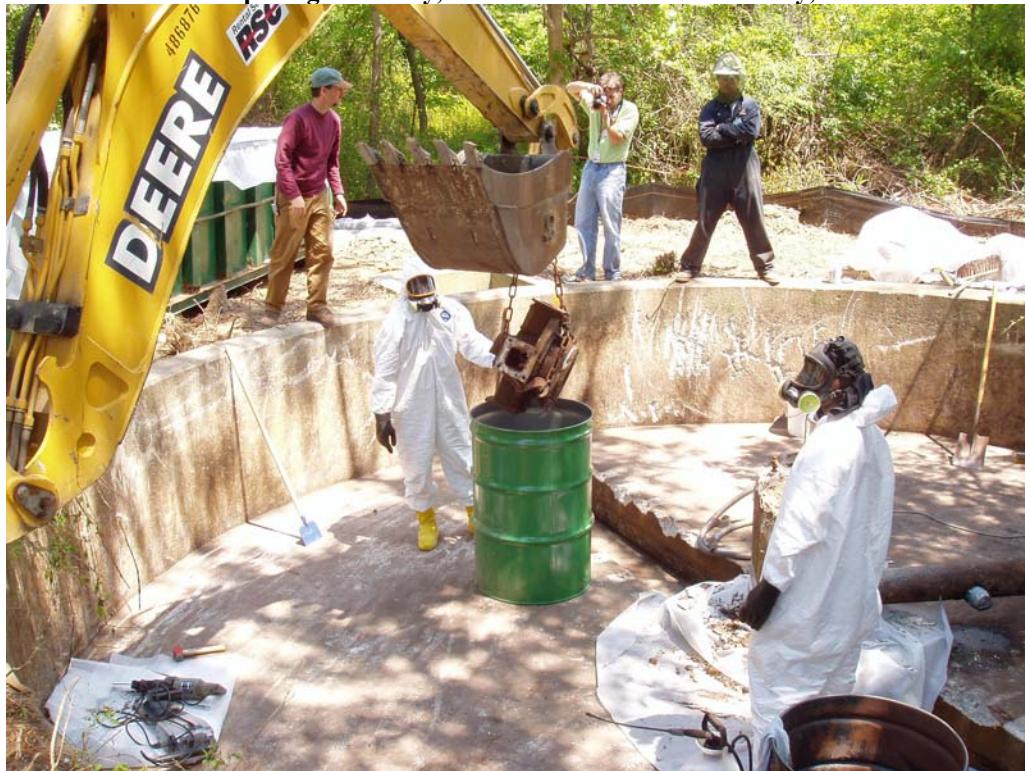
**PHOTO NUMBER:** WFF1-TCRA-051706-01      **DATE:** May 17, 2006      **PHOTOGRAPHY BY:** Greg Ford

**SCENE:** Placement of the mercury seal portion of the rotary distributor in 85-gallon drum. Photograph taken facing northeast.

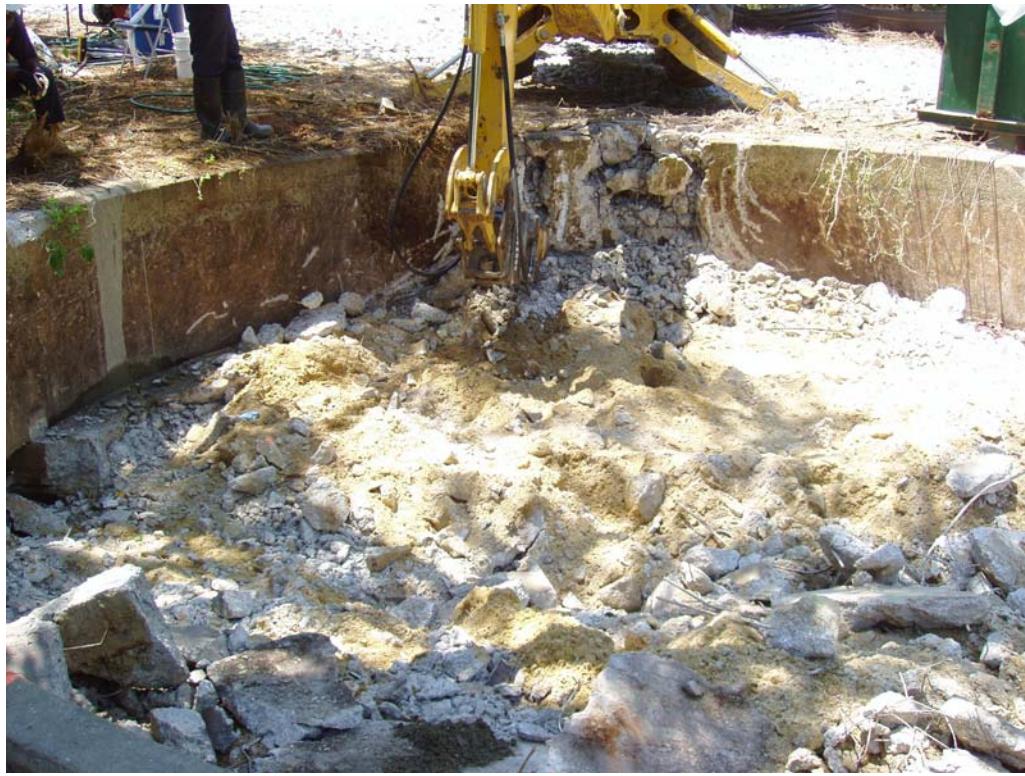
**PHOTO NUMBER:** WFF1-TCRA-051806-01      **DATE:** May 18, 2006      **PHOTOGRAPHY BY:** Greg Ford

**SCENE:** Demolition of trickling filter tank. Photograph taken facing southwest.

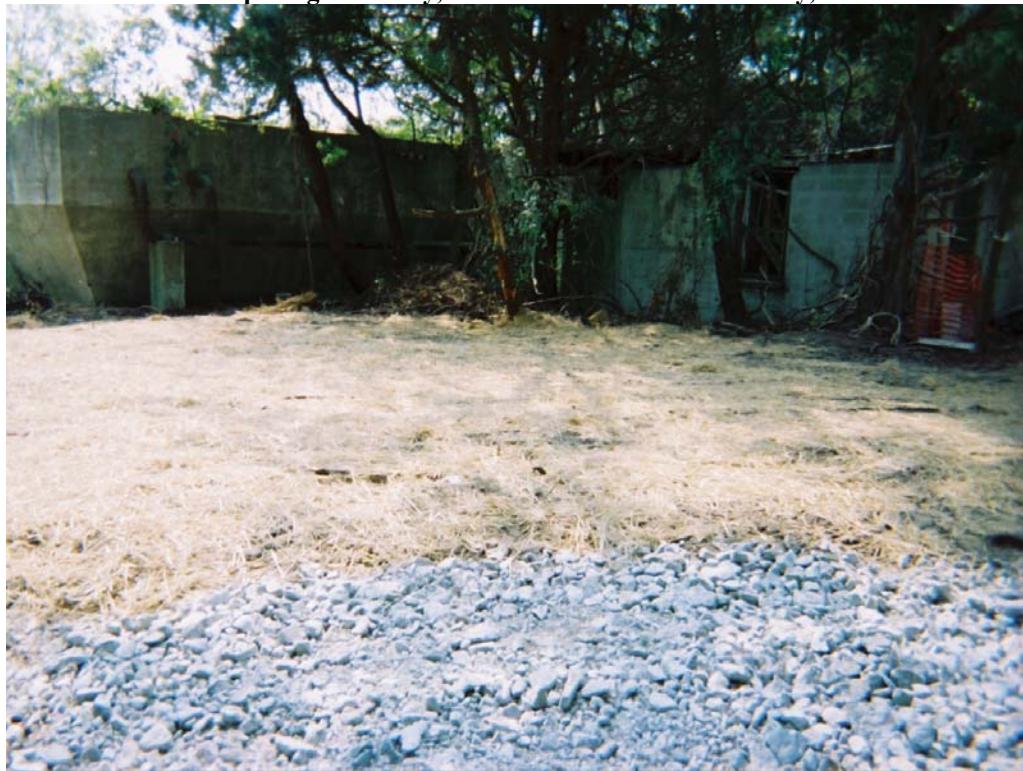
**PHOTO NUMBER:** WFF1-TCRA-060106-01      **DATE:** June 01, 2006      **PHOTOGRAPHY BY:** Ed Mackey

**SCENE:** Site restoration. Concrete settling tank and cinder-block pump house building located in background. Photograph taken facing southeast.

Site restoration included activities needed to return the site to pre-mobilization conditions. Following completion of the TCRA, the bottom of the trickling filter tank area was backfilled to ground surface with clean, off-site borrow material from C. Lee Davis, Inc. On May 9, 2006, a sample was collected from the backfill material (WFF-TCRA-BKG) and analyzed for TAL list metals, target compound list (TCL) VOCs and SVOCs, and total petroleum hydrocarbons (TPHs). Analytical results of the backfill sample are discussed in Section 4.0 and summarized in Table 4-1.

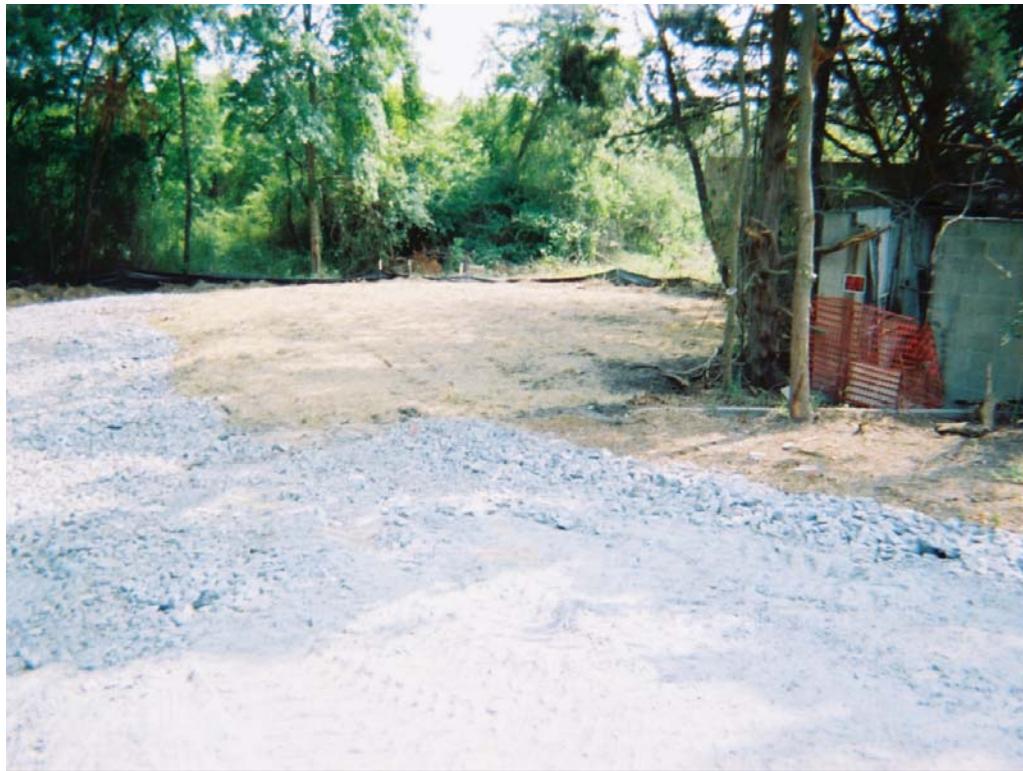
**PHOTO NUMBER:** WFF1-TCRA-060106-02      **DATE:** June 01, 2006      **PHOTOGRAPHY BY:** Ed Mackey

**SCENE:** Site restoration. Cinder-block pump house building located on east (right) side of photograph. Photograph taken facing northeast.

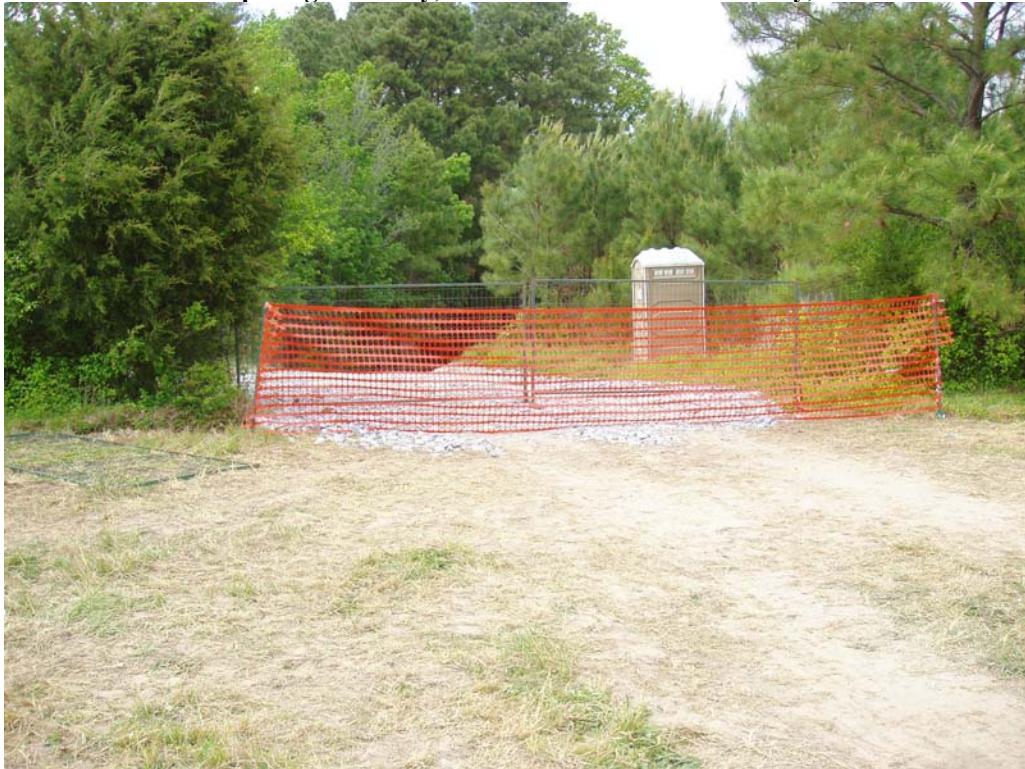
**PHOTO NUMBER:** WFF1-TCRA-051906-04      **DATE:** May 19, 2006      **PHOTOGRAPHY BY:** Greg Ford

**SCENE:** Metal fence and nigh visibility fence restricting access to site and temporary gravel access road. Photograph taken from the taxiway that parallels runway 10-28; facing east.

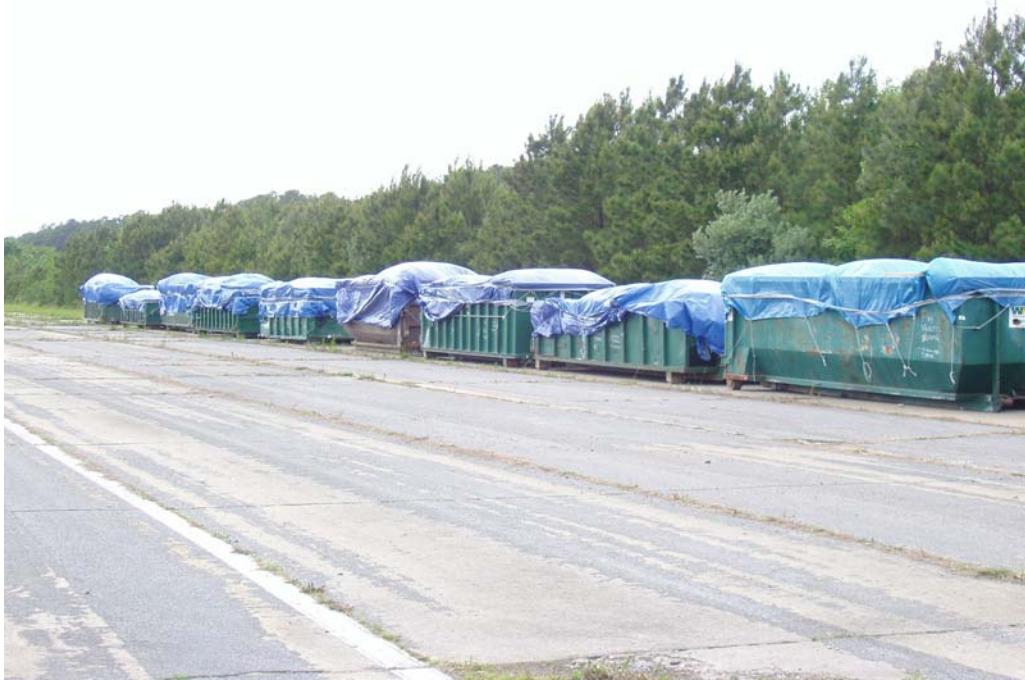
**PHOTO NUMBER:** WFF1-TCRA-051906-05      **DATE:** May 19, 2006      **PHOTOGRAPHY BY:** Greg Ford

**SCENE:** Covered roll-off containers staged along the taxiway that parallels runway 10-28. Photograph taken facing northwest.
