**FINAL TECHNICAL MEMORANDUM**

**BENTHIC HABITAT SURVEY OF  
TWO OFFSHORE BORROW SITES**

**WALLOPS FLIGHT FACILITY  
SHORELINE RESTORATION AND  
INFRASTRUCTURE PROTECTION  
PROGRAM**

**November 2009**

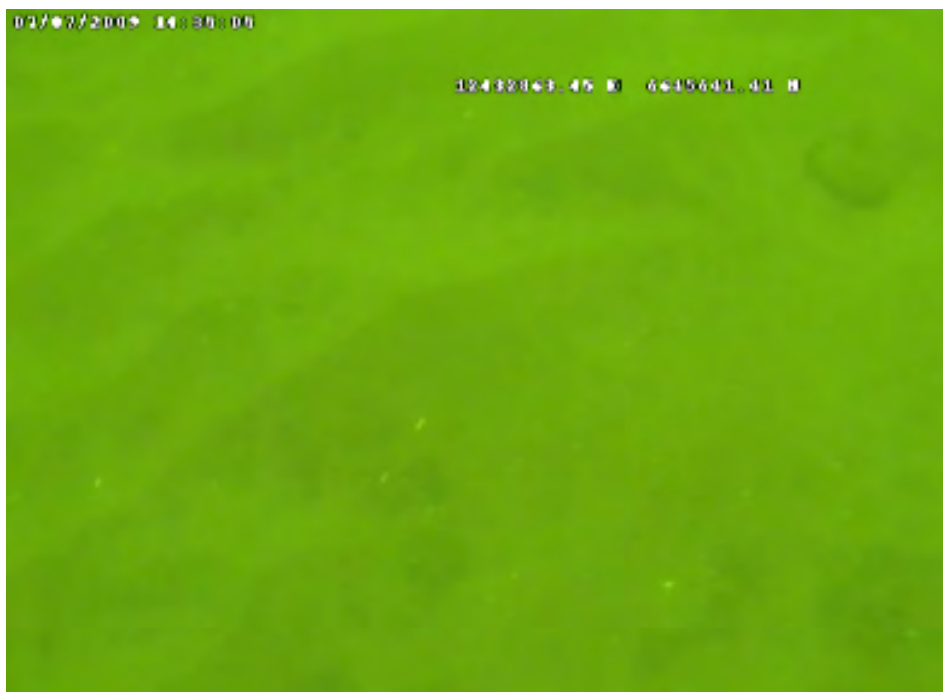
**Photo A-10:** Station #38 from Unnamed Shoal A at a depth of 33 ft depicting well-defined ripple marks and a sand dollar (*Echinarachinus parma*) in upper right quadrant.

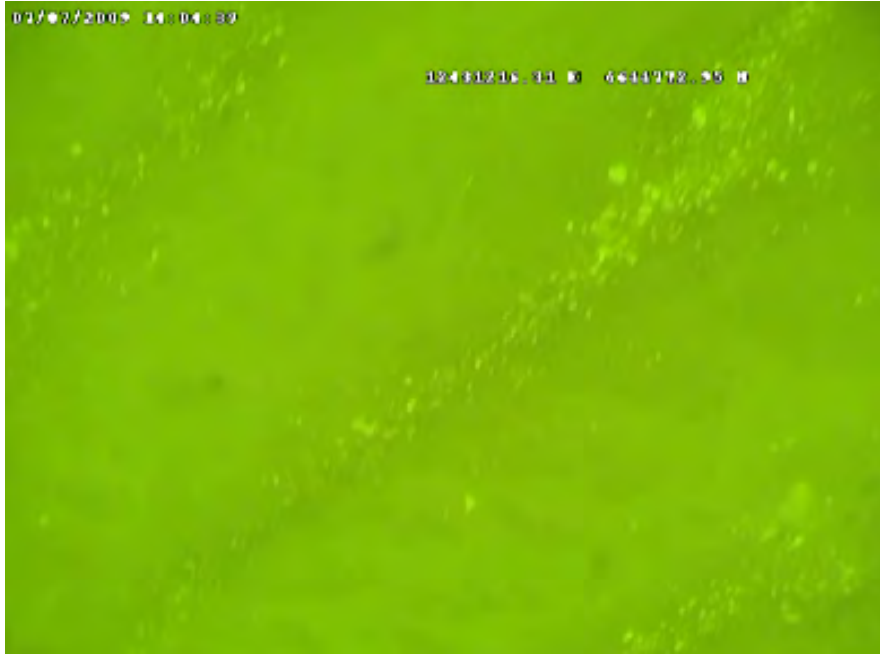
**Photo A-11:** Station #39 from Unnamed Shoal A at a depth of 31 ft. Shell concentrated in troughs of ripple marks.

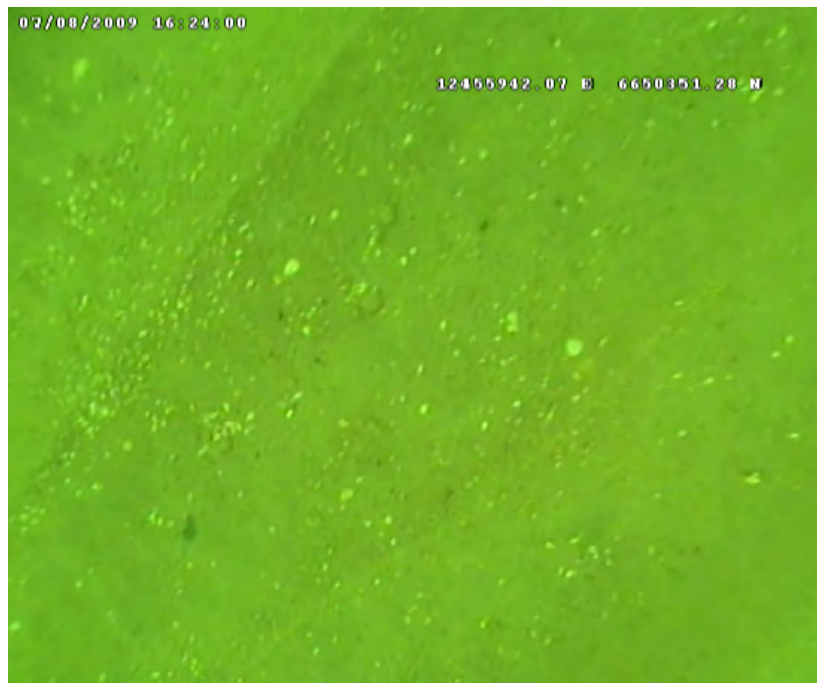
**Photo B-2:** Station #2 Unnamed Shoal B at a depth of 42 ft with well-defined ripple marks and low shell content characteristic of stations on shoal crest.

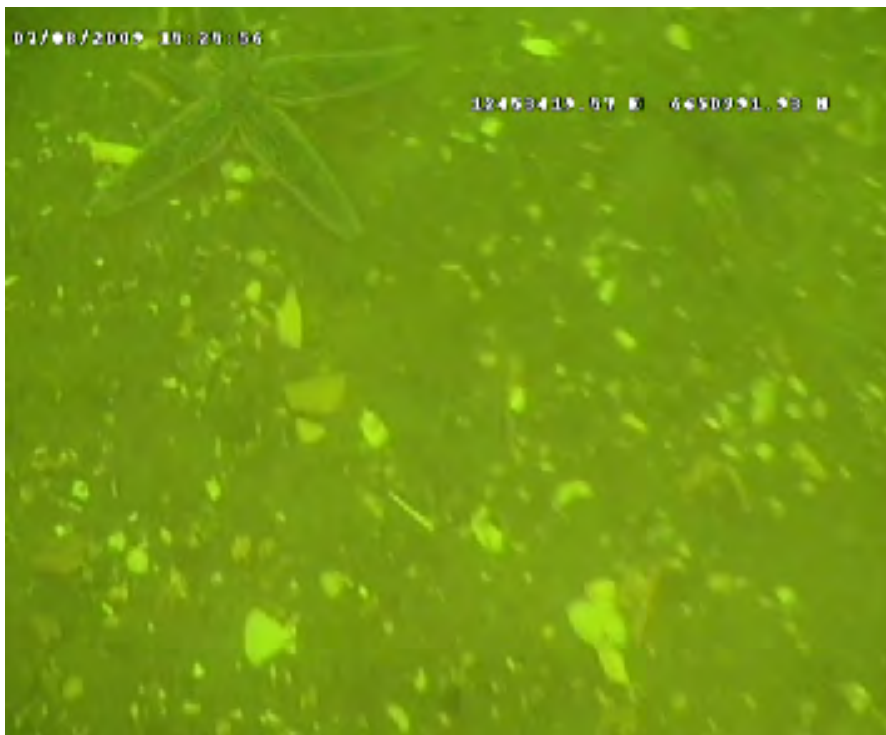
**Photo B-4:** Station #9 Unnamed Shoal B at a depth of 55 ft. Starfish (*Astropecten* spp.) in upper left quadrant.

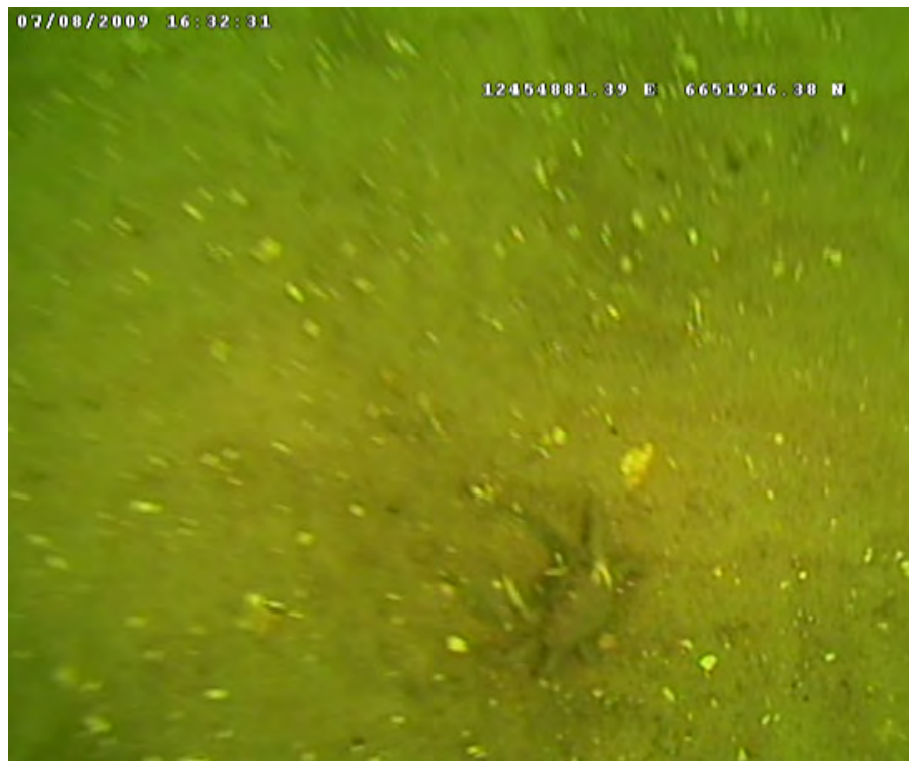
**Photo B-6:** Station #10 Unnamed Shoal B at a depth of 55 ft. Portly spider crab (*Libinia emarginata*) in lower right quadrant.

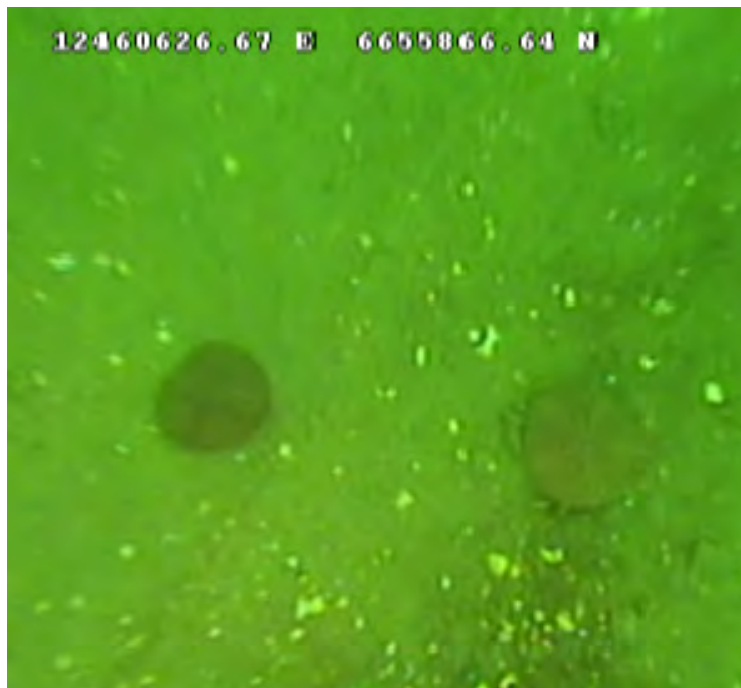
**Photo B-10:** Sand dollars (*Echinarachinus parma*) from Station #14 Unnamed Shoal B at a depth of 48 ft.

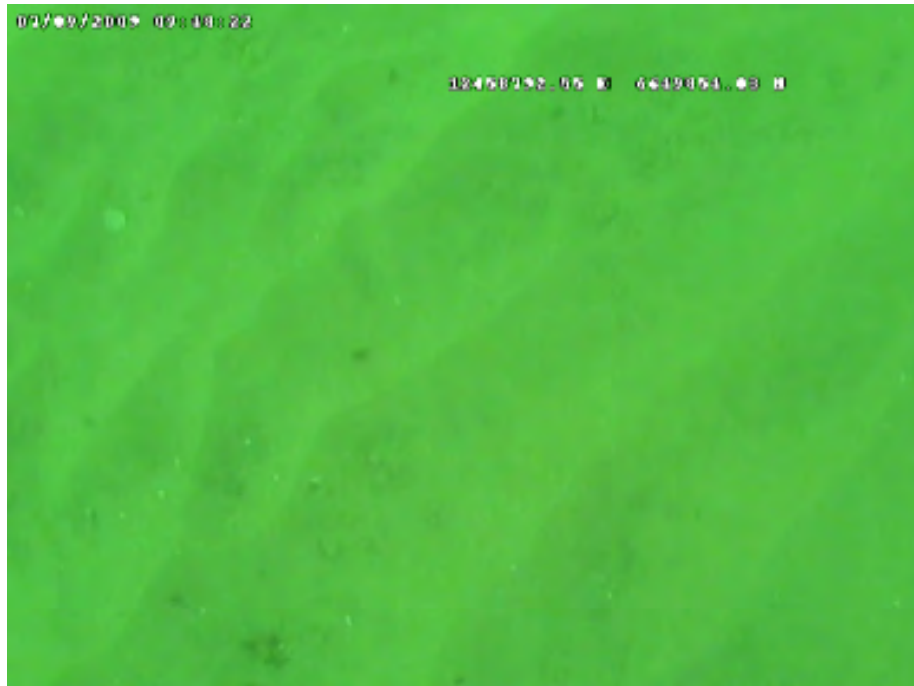
**Photo B-13:** Station #22 from Unnamed Shoal B at a depth of approximately 43 ft with well-defined ripple marks and low shell content.

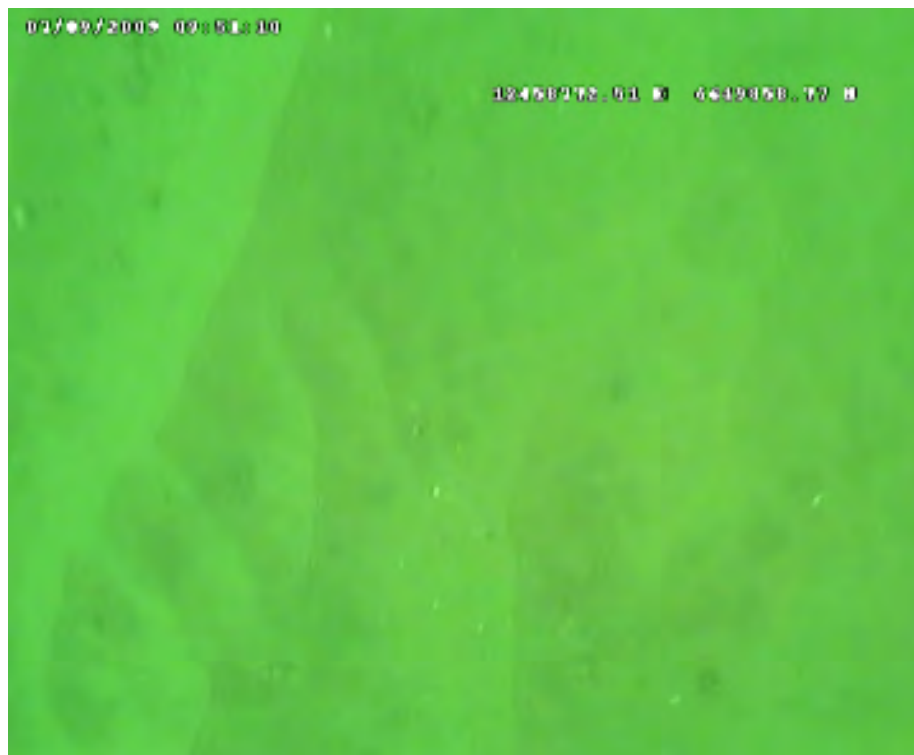
**Photo B-14:** Station #22 from Unnamed Shoal B at a depth of approximately 43 ft with well-defined ripple marks and low shell content.

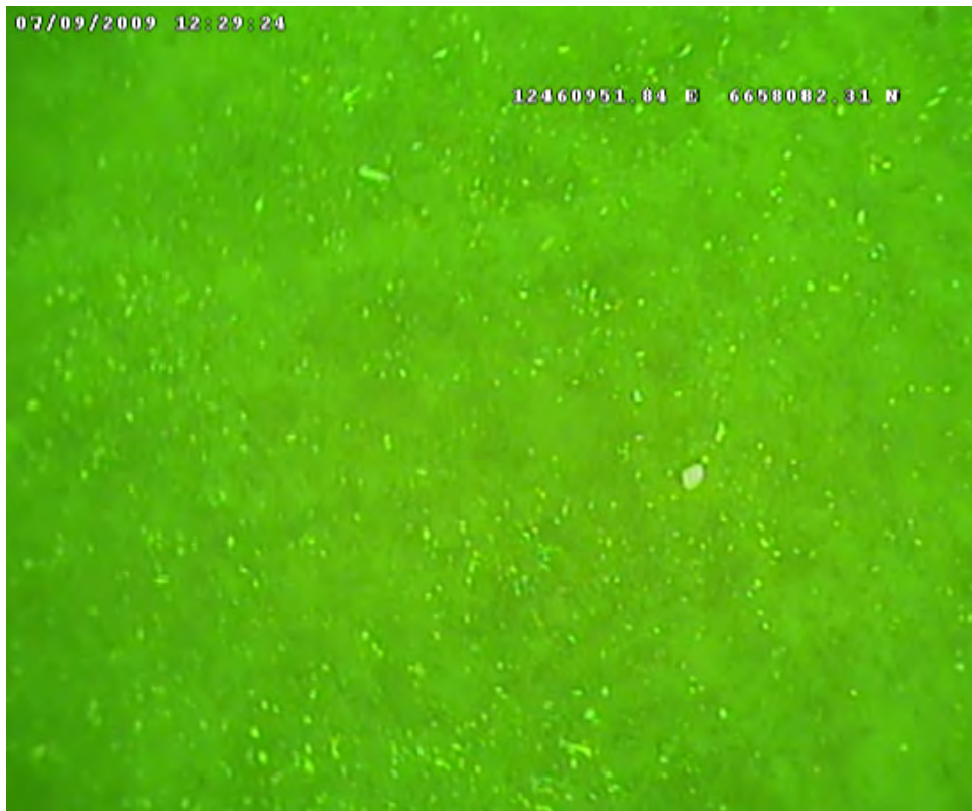
**Photo B-17:** Station #31 from Unnamed Shoal B at a depth of approximately 60 ft with lack of well-defined bedforms.

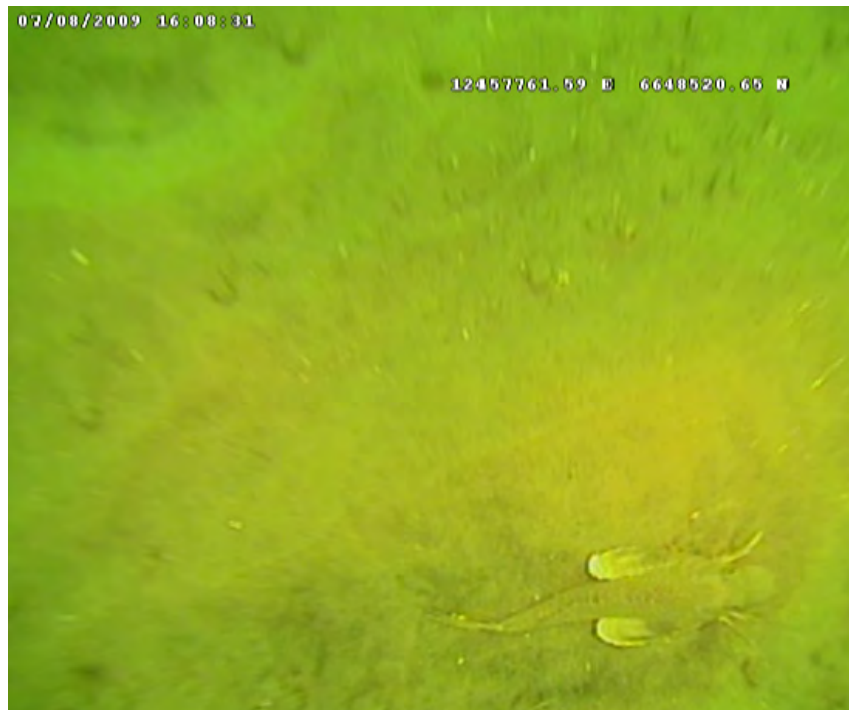
**Photo B-20:** Sea robin (*Prionotus* spp.) in lower right quadrant from Station #39 Unnamed Shoal B at a depth of 56 ft.

The benthic habitats and epifaunal communities were similar on the two shoals. The benthic habitat was comprised of unvegetated soft sediment dominated by fine to medium sand. No hard bottom habitats were observed. Dominant epifaunal benthos included; hermit crabs (*Pagurus* spp.) (Photo B-16), sand dollars (*Echinarachinus parma*) (Photo B-9, B-10), crabs [*Libinia emarginata* (Photo A-7), *Cancer* spp. (Photo B-15)], moon snail (*Polinices* spp.) (Photo B-7) and whelk (*Busycon* spp.). Hermit crabs were observed at most of the stations. Moon snail sand collars or egg cases (Photo B-7) were observed at many of the stations. In addition, there was a patch of ascidians (sea squirts) located at Station 24 in approximately 58 ft of water. Fish were rarely seen at any of the stations; those that were observed were primarily (*Prionotus* spp.) (Photo B-20).

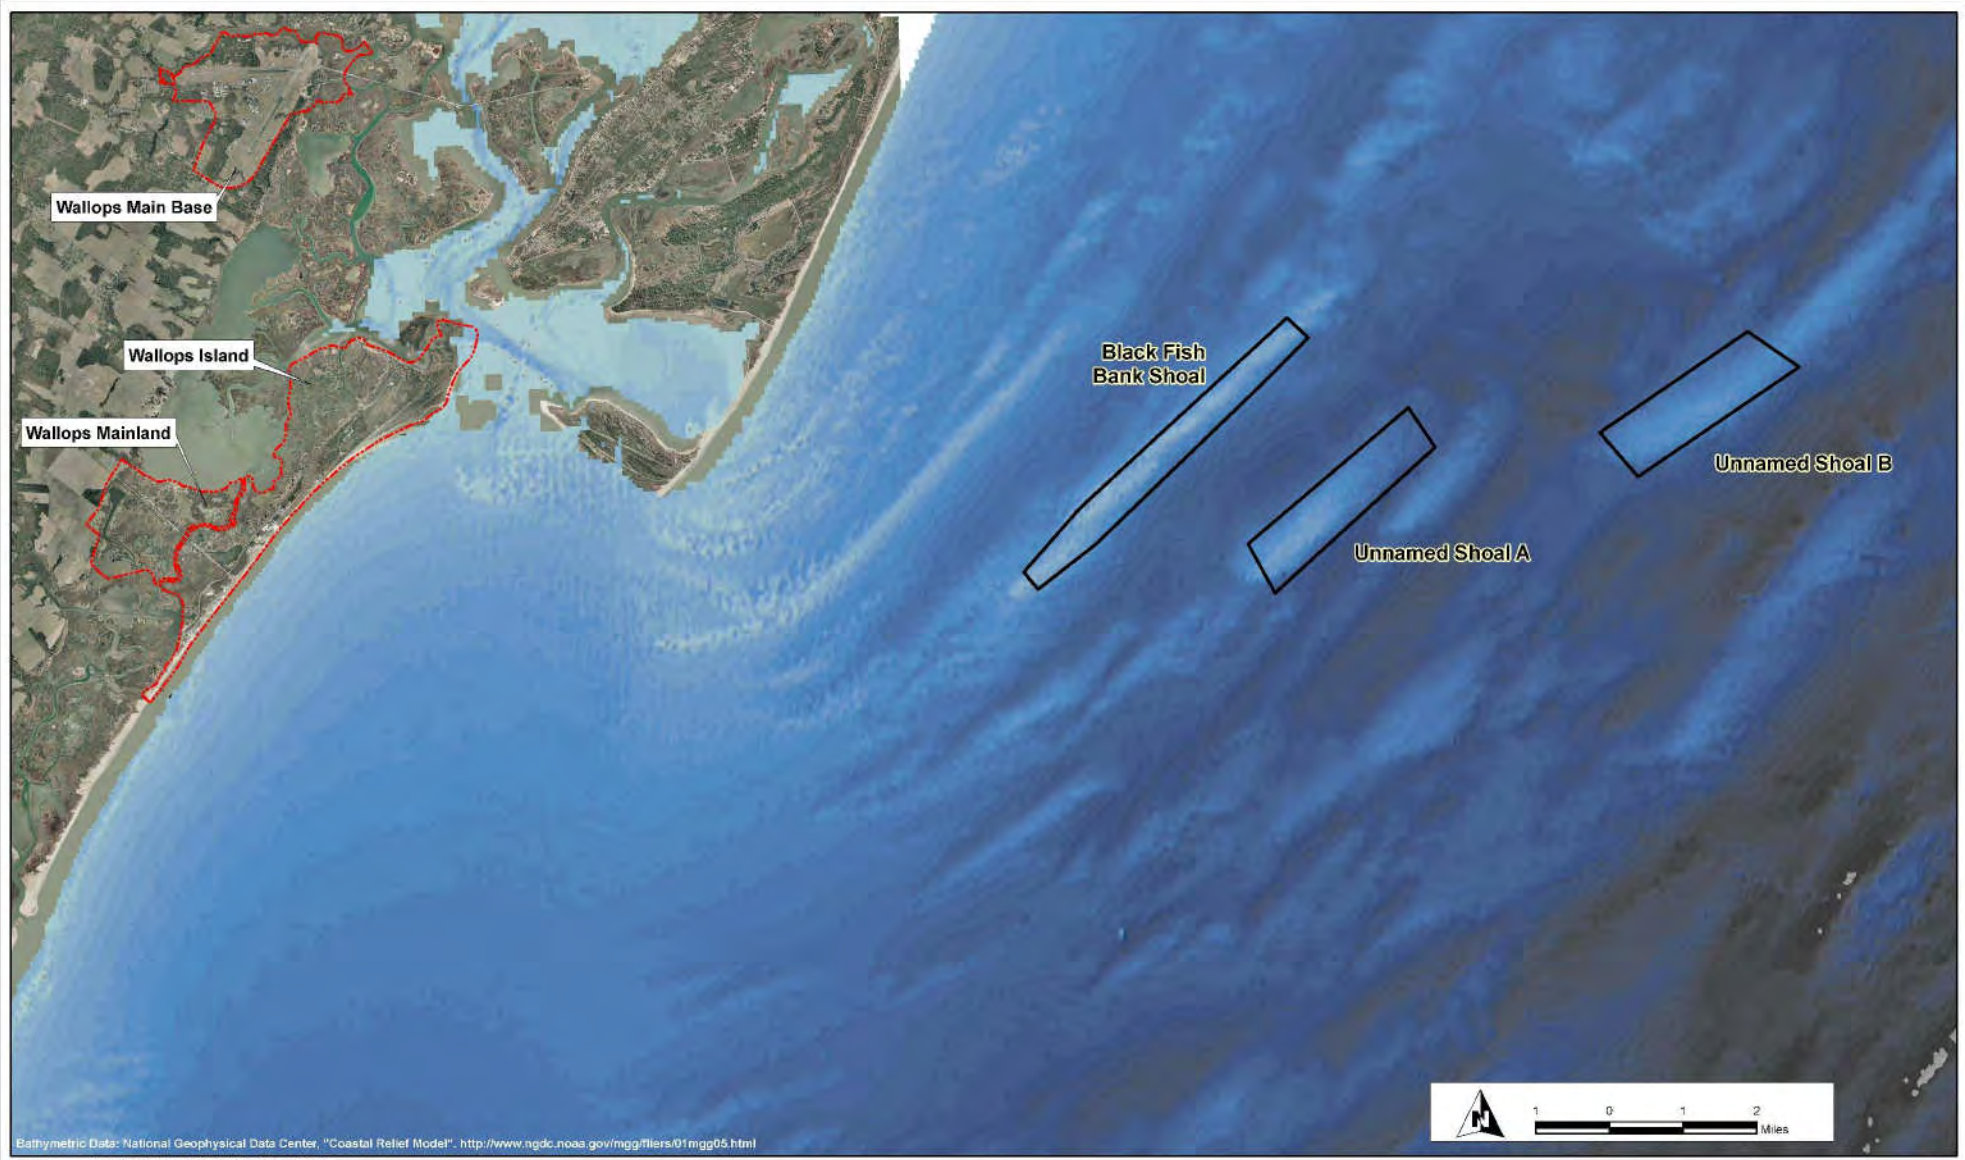
<b>Title: Offshore Bathymetry</b>	
URS Proj No: 15301785	Figure: 1
Client: NASA	
Shoreline Restoration Environmental Impact Statement

The video survey was conducted on two offshore sand shoals (Unnamed Shoal A and B) that are being evaluated as potential borrow sources for beachfill sand for NASA's SRIPP (Attachment 1 - Figure 1). These sand ridges trend from northeast to southwest and the shoal crests and generally get deeper further offshore.
